# **SYDNEY UNIVERSITY SUSAN WAKIL HEALTH BUILDING STAGE 1 DEVELOPMENT - SSD 7974**

## **Independent Environment Audit 4 Report**

18329  
Sydney University Susan Wakil  
Health Building Stage 1  
Development, Independent  
Environment Audit 4 Report  
0.2  
19 May 2020

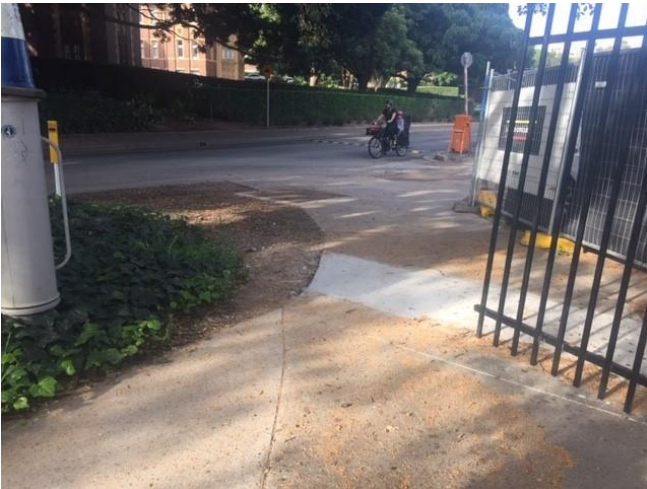
A photograph showing a paved area with a metal gate and some landscaping. The gate is partially open, and there are some plants and a person on a bicycle in the background.</div> <div data-bbox="797 726 2051 790"><p><b>Stabilisation of landscaping around the site to adhere to the landscaping design report and planting schedule. Including outside the site perimeter, but within the project boundary.</b></p></div>
Evidence of stormwater drainage implementation	<div data-bbox="797 833 1408 1295">

No.	Category	Action	Responsibility	Timing	Status
1	Opportunity for improvement	Stabilisation of landscaping around the site to adhere to the landscaping design report and planting schedule. Including outside the site perimeter, but within the project boundary.	Laing O'Rourke	Immediate	Open
2	Opportunity for improvement	Irrigation hosing hung around the perimeter fence to be monitored for leakages and spray onto pathways to be rectified.	Laing O'Rourke	Immediate	Open
3	Opportunity for improvement	Stormwater drainage under the building at the basement level to be monitored to make sure drains are clear of debris/blockages post construction. It is recommended that these stormwater drains are monitored during operational site inspections in the future.	Laing O'Rourke	Immediate	Open
4	Opportunity for improvement	The compliance matrix in Appendix A is to be updated to include Modification 2 conditions and the outstanding CC3 actions are to be closed out, with evidence to provided to NSW DPIE.	Laing O'Rourke	Immediate	Open

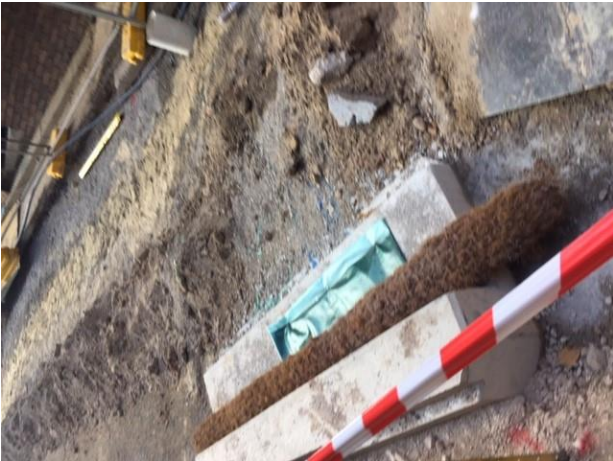
A photograph showing a stormwater drainage system with a red and white striped barrier. The barrier is placed over a concrete structure, and there is some debris and a green bag nearby.</div> <div data-bbox="797 1295 2051 1396"><p><b>Evidence of stormwater protection in place during construction. Stormwater drainage under the building at the basement level to be monitored to make sure drains are clear of debris/blockages post construction. It is recommended that these stormwater drains are monitored during operational site inspections in the future.</b></p></div>

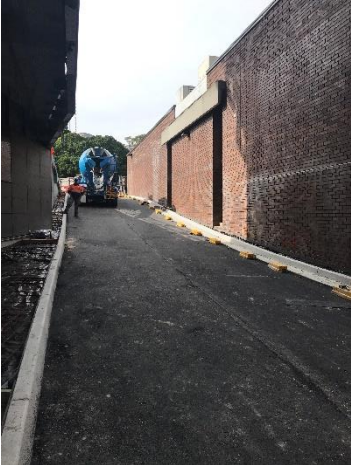
</div> <p data-bbox="797 708 2022 762">Asphalting of the access road was conducted after Audit 4 for dust mitigation, photo provided by Laing O'Rourke on 9<sup>th</sup> May 2020.</p>
<p data-bbox="188 767 792 834">Evidence of incident management reporting (i.e. incident register and follow up actions)</p>	<p data-bbox="792 767 2051 834">One incident report was provided to RPS for this audit period, the Senior Sustainability and Environmental Adviser provided evidence of close out, refer to Section 2 for further details.</p>
<p data-bbox="188 834 792 981">Evidence of implementation of the CEMP and sub plans (i.e. erosion and sediment control plans, waste/materials tracking register/waste dockets, noise and vibration monitoring records, out of hours works approvals, asbestos checklist).</p>	<div data-bbox="797 841 1444 1331" data-label="Image">

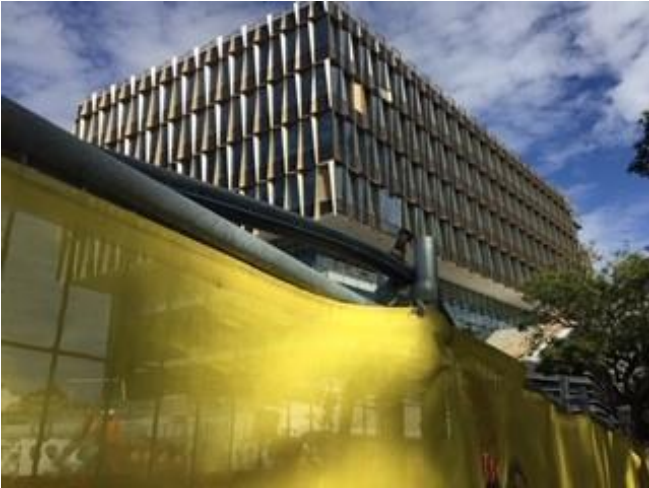
</div> <p data-bbox="797 1339 2022 1393">Irrigation hosing hung around the perimeter fence to be monitored for leakages and spray onto pathways to be rectified, by potentially lowering and turning the spouts onto site.</p>

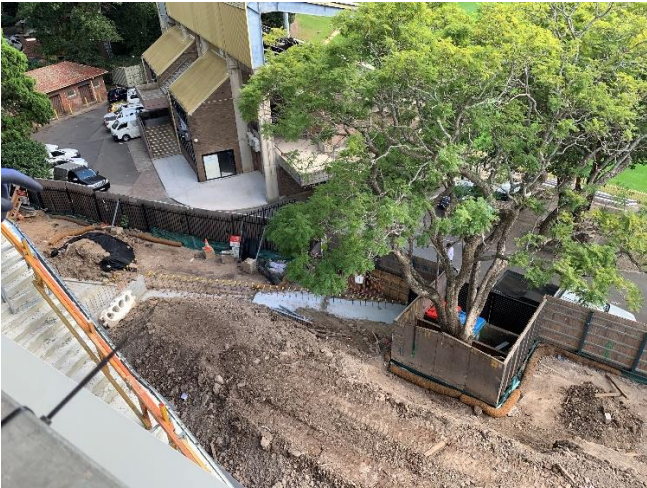
An aerial photograph showing a large, mature tree with a dense canopy of green leaves. A rectangular metal fence, likely a Tree Protection Zone (TPZ) fence, encircles the base of the tree. The ground around the tree is disturbed, with exposed soil and some construction equipment visible. In the background, there are buildings and a parking lot.</div> <p>The Tree Protection Zone (around the over 100-year-old Jacaranda) was still intact and in place in Audit 4.</p>
Backflow Prevention	<div>

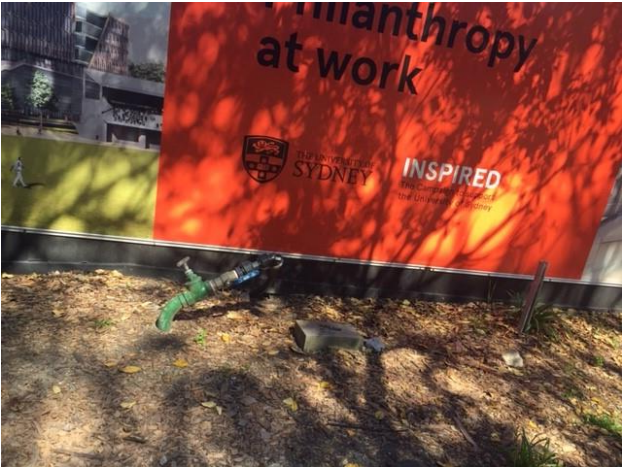
A photograph of a red banner or wall with the text 'Humanity at work' in white. Below the text are logos for 'The University of Sydney' and 'INSPIRED'. The banner is set against a background of trees and foliage. In the foreground, there is a green pipe or hose lying on the ground.</div> <p><b>Recommendation for the Backflow Prevention Containment Device at the perimeter entrance to be installed and tested to <i>Water Supply - Backflow Prevention Australian Standards</i> by a qualified plumber.</b></p>

9	Audit 3: Opportunity for improvement	Recommendation for the Backflow Prevention Containment Device at the perimeter entrance to be installed and tested to Water Supply - Backflow Prevention Australian Standards by a qualified plumber.	Laing O'Rourke	Ongoing	Open, to be installed once construction is complete.
10	Audit 3: Opportunity for improvement	Recommendation for reuse of pallets and wooden spools from materials delivery, LoR advised the manufacturer would not accept these for recycling, potentially investigate other avenues such as Reverse Garbage or Palletable Furniture, Marrickville ( <a href="https://reversegarbage.org.au/">https://reversegarbage.org.au/</a> ).	Laing O'Rourke	Ongoing	Open, Laing O'Rourke are looking into this.
11	Audit 3: Opportunity for improvement	Recommendation for lead wall sheeting offcuts to be recycled as metal waste through a registered waste facility.	Laing O'Rourke	Closed	Closed out in Audit 4, Laing O'Rourke advised the waste contractor will recycle these.
