RICHARD CROOKES

SYDNEY BIOMEDICAL ACCELERATOR  
1330

# CONSTRUCTION ENVIRONMENTAL MANAGEMENT PLAN (CEMP)

30 June 2025

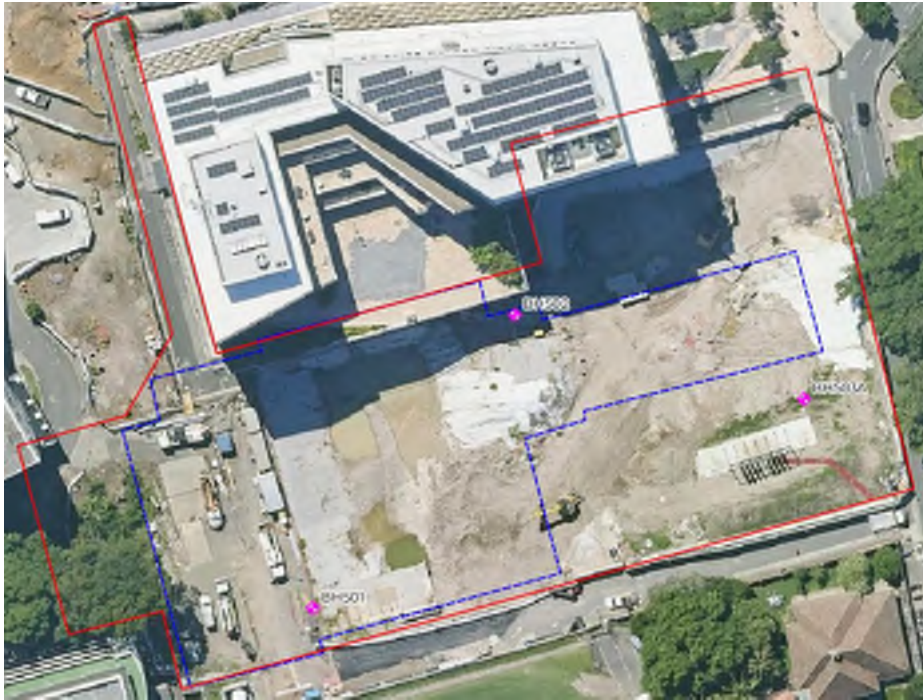
FIGURE 4: TEST LOCATION PLAN

Samples were analysed at a NATA accredited laboratory for a suite of Contaminants of Potential Concern (CoPC). Elevated concentrations of heavy metals (copper and zinc) were detected, which are summarised below.

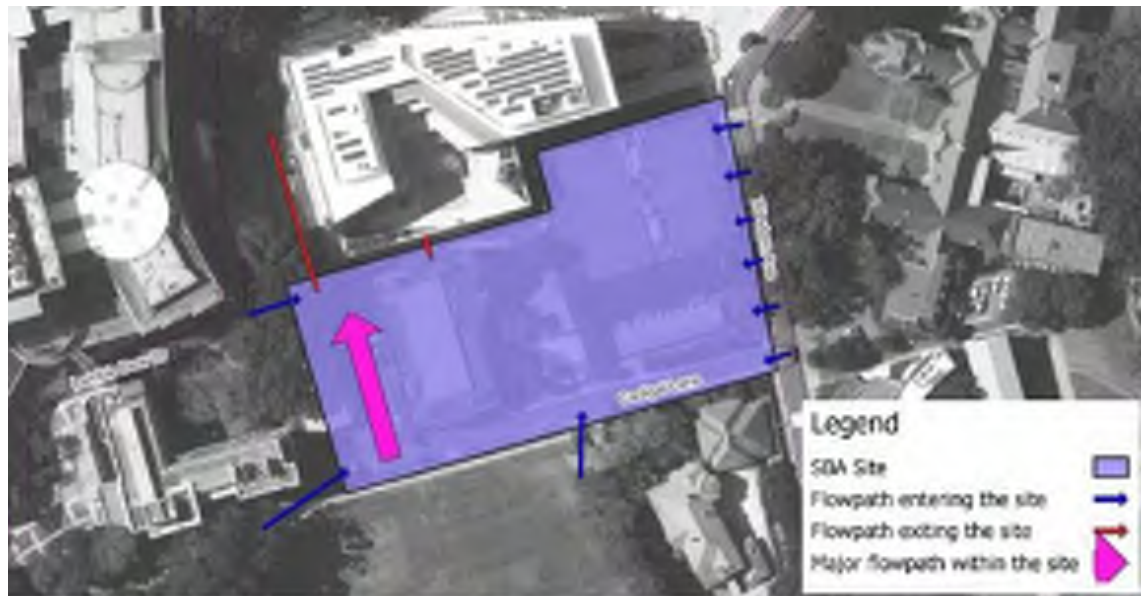
FIGURE 8: OVERLAND FLOW PATHS

Flooding at the site will not be preceded by any formal warning. Flooding will typically occur during or immediately following short rainfall events with high intensity rainfall lasting up to six hours. These rainfall events can cause 'flash flooding', which is the main flood risk for the site.

Flooding is anticipated to last a matter of minutes or at worst, several hours.

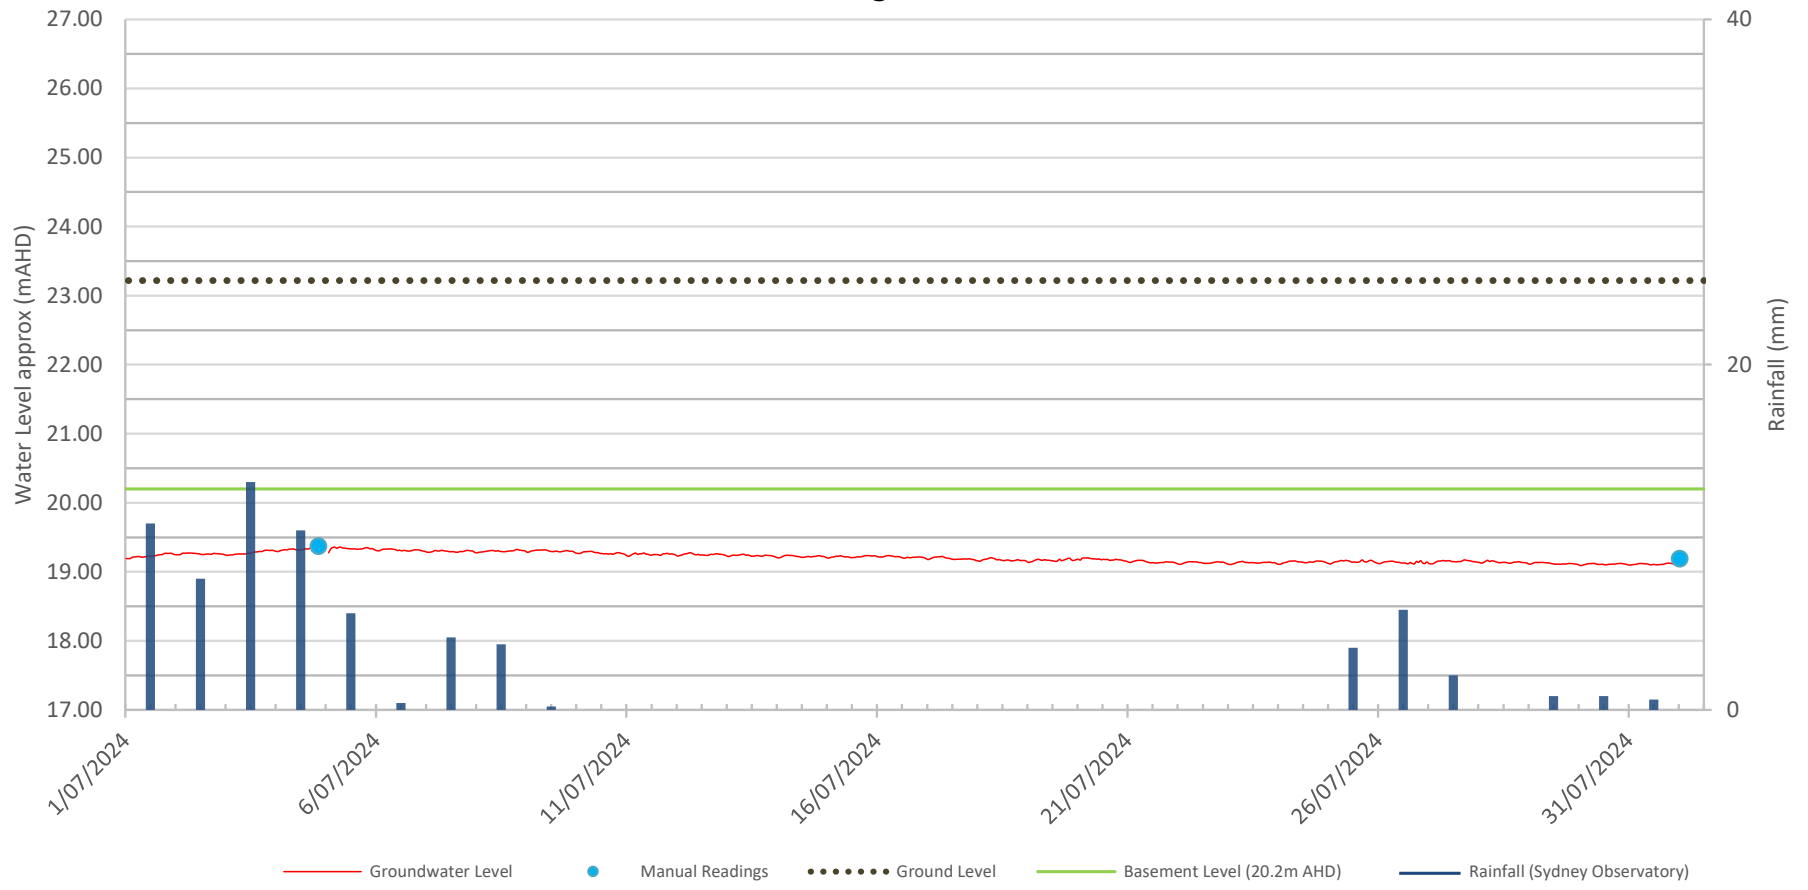
### Monitoring Well: BH501

Note: Reading Interval = 1 hour

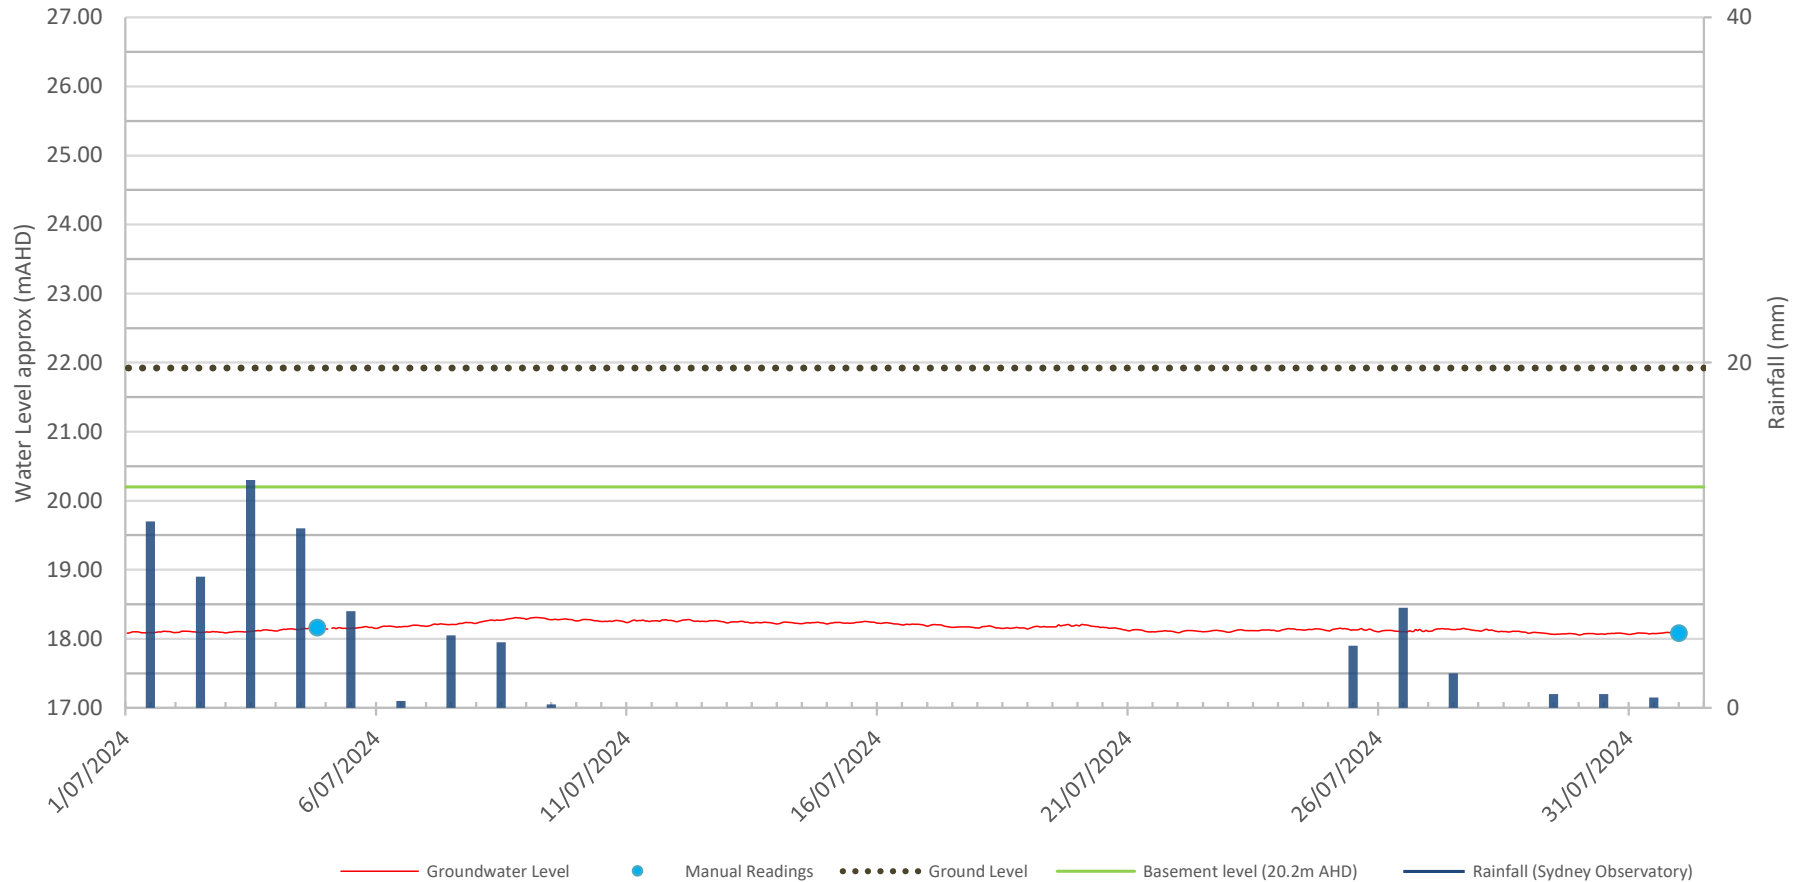
### Monitoring Well: BH502

Note: Reading Interval = 1 hour

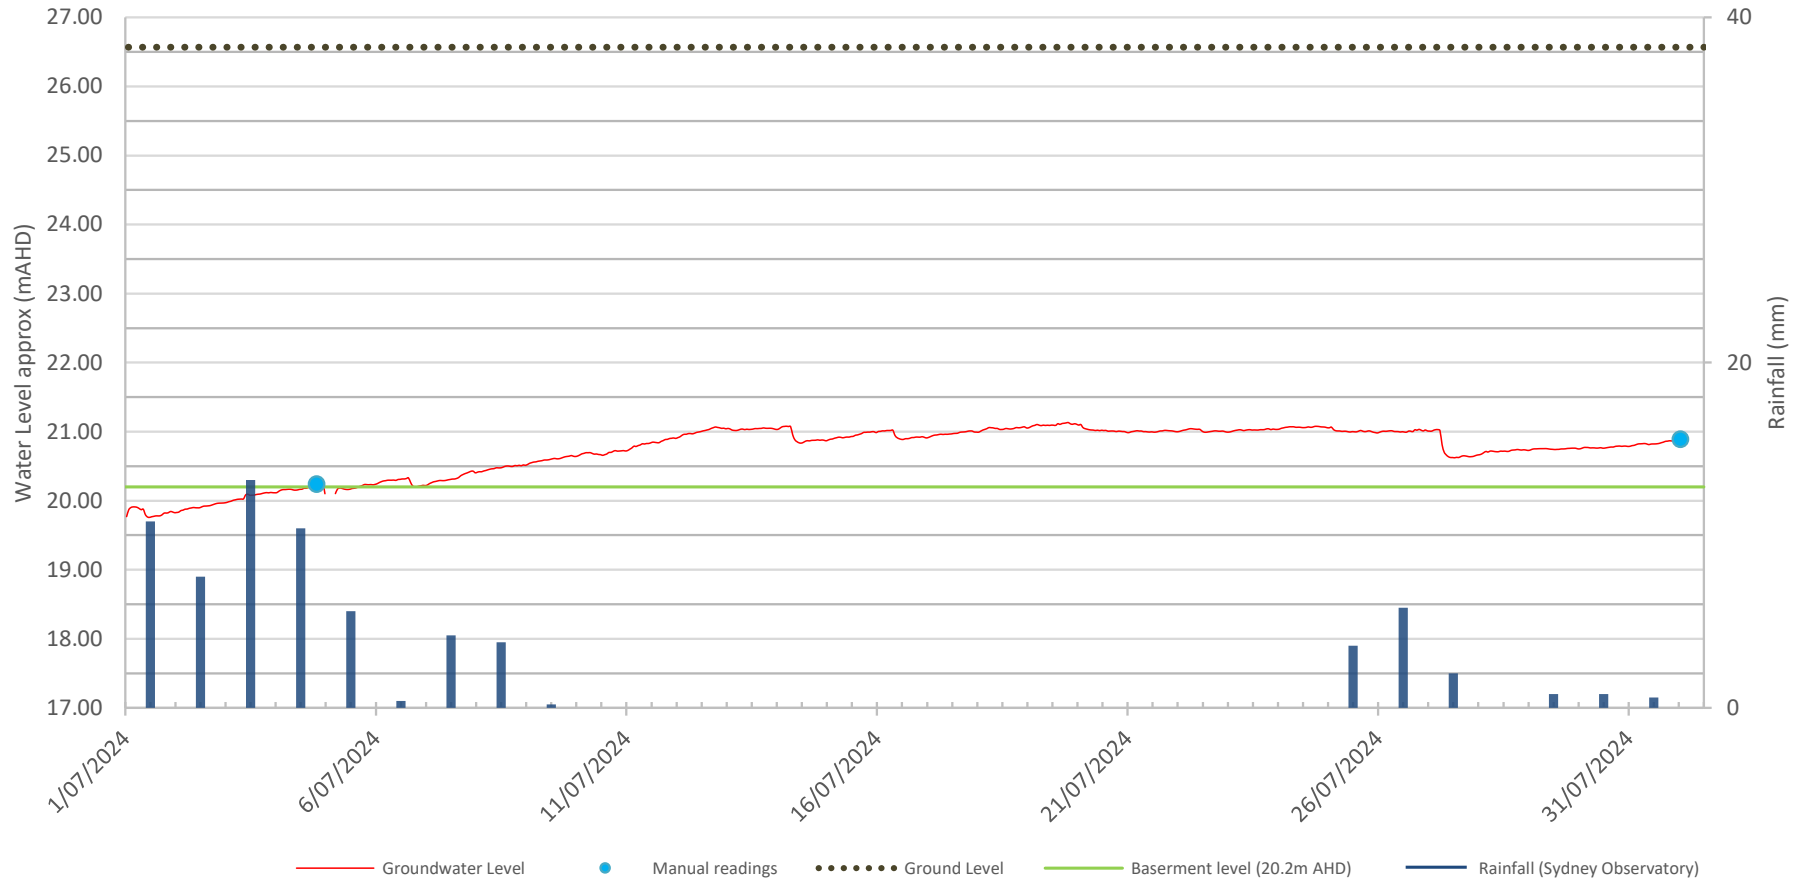
### Monitoring Well: BH503A

Note: Reading Interval = 1 hour

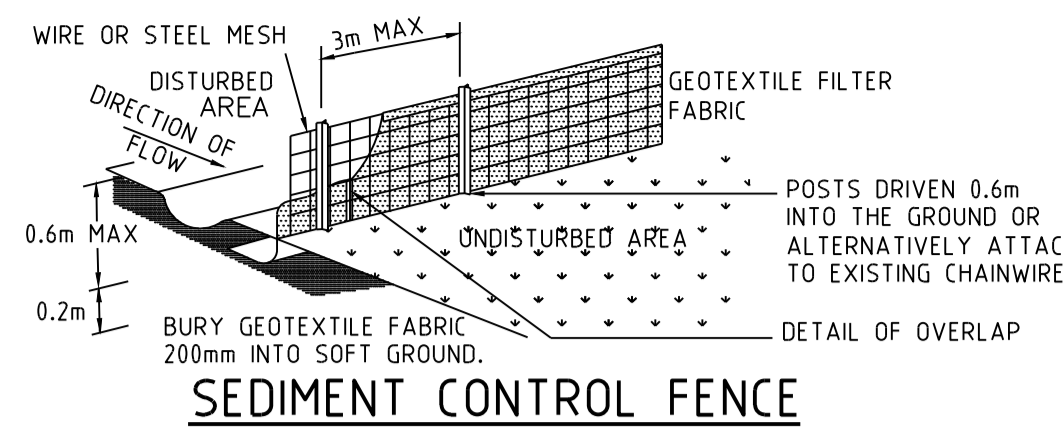
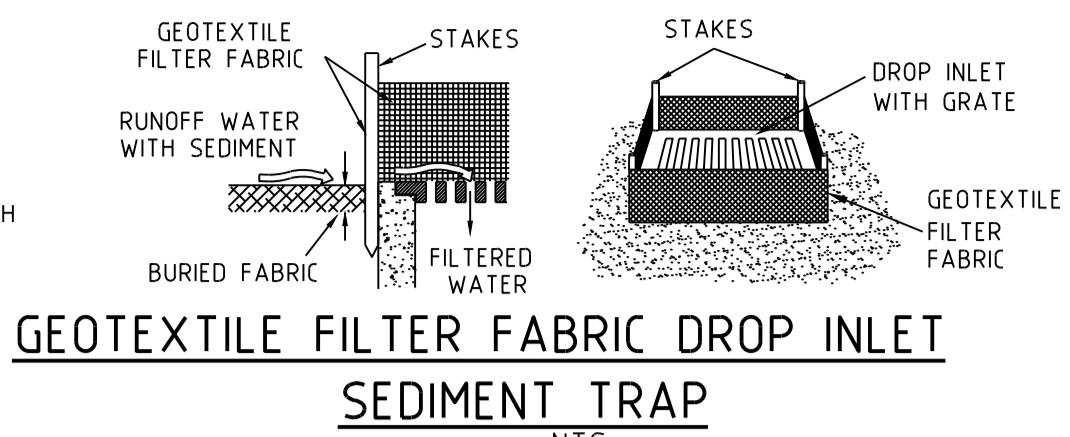
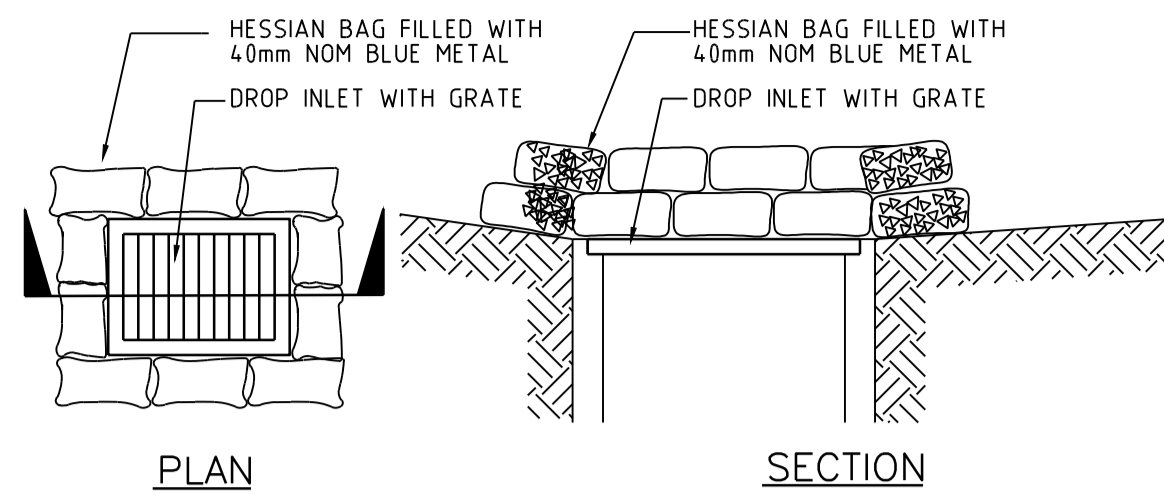
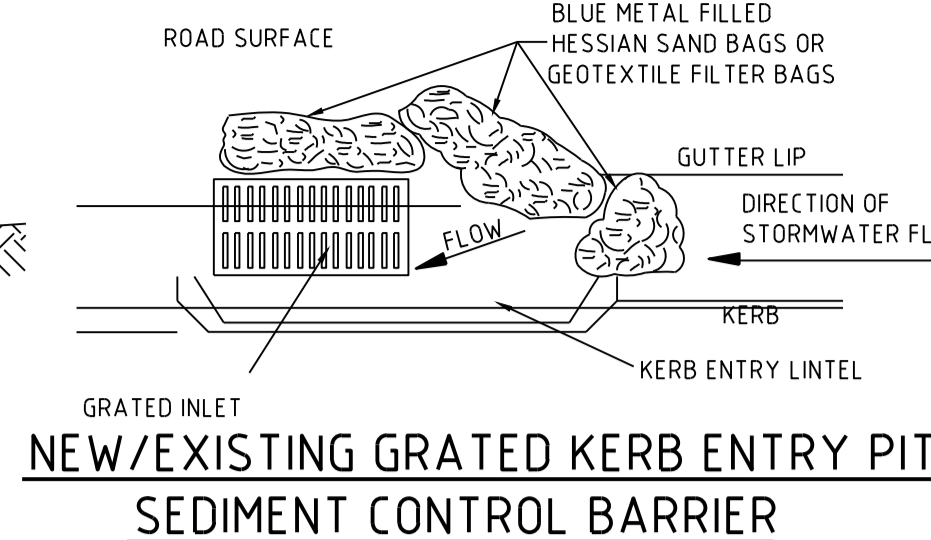
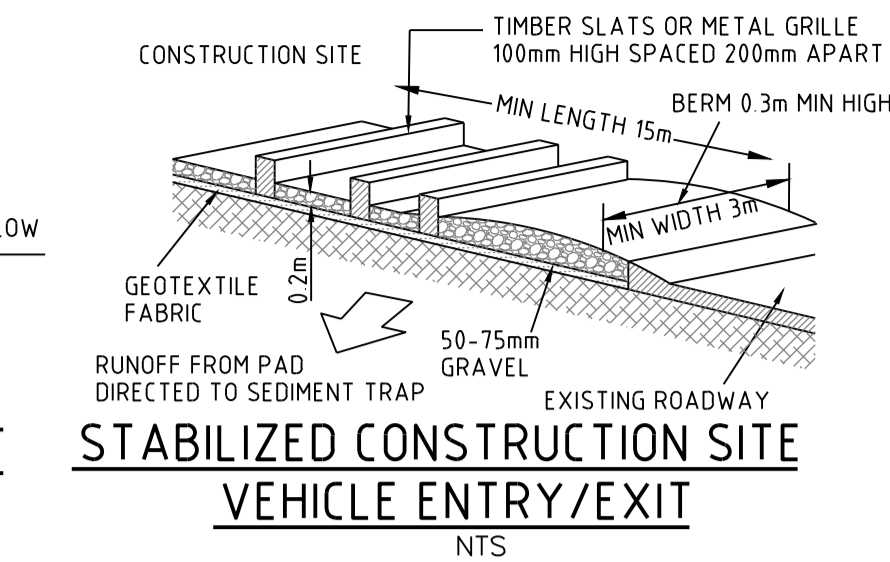
## 6.9 EROSION AND SEDIMENT CONTROL DETAILS

- SITE ENTRY/EXIT NOTES:-**
- ALL VEHICLE ENTRANCES & EXITS TO THE CONSTRUCTION SITE MUST BE STABILIZED TO PREVENT THEM BECOMING A SOURCE OF SEDIMENT. BY PROVIDING A VEHICLE SHAKE AREA, THIS MAY CONSIST OF A TIMBER, CONCRETE OR STEEL SHAKER GRID OR RUBBLE AREA.
  - THE VEHICLE EXIT AREA IS TO BE MAINTAINED IN A CLEAN & SERVICEABLE CONDITION DURING THE TOTAL TIME OF USAGE.
  - ANY UNSEALED ROAD BETWEEN THE DEVICE AND COUNCIL'S ROADWAY IS TO BE TOPPED WITH 100mm THICK, 40mm NOMINAL SIZE AGGREGATE.
  - PUBLIC ROADS MUST BE KEPT FREE OF DIRT AND MUD. SEDIMENT TRACKED ONTO THE PUBLIC ROADWAY BY VEHICLES LEAVING THE CONSTRUCTION SITE IS TO BE SWEEPED UP IMMEDIATELY.
  - FENCES SHOULD BE ERECTED TO ENSURE VEHICLES CAN NOT BYPASS THE STABILIZED ACCESS POINTS, UNLESS COMING FROM A STABILIZED AREA.

- SEDIMENT FENCE NOTES:-**
- CONSTRUCT SEDIMENT FENCE AS CLOSE AS POSSIBLE TO PARALLEL TO THE CONTOURS OF THE SITE OR AT THE TOE OF A SLOPE.
  - DRIVE 1.5 METRE LONG STAR PICKETS INTO GROUND SUFFICIENT TO PROVIDE RIGID SUPPORT, 3 METERS APART. WHERE THERE IS INSUFFICIENT SOIL DEPTH OVER ROCK, HOLES ARE TO BE DRILLED INTO ROCK TO ACCEPT THE STAR PICKETS.

- SEDIMENT BARRIER FOR PITS & PIPES, NOTES:-**
- SLEEVES ARE TO BE MADE FROM GEOTEXTILE FABRIC LONGER THEN THE LENGTH OF THE INLET PIT.
  - FILL SLEEVE WITH 5 OR 10mm CLEAN GRAVEL.
  - PLACE THE SLEEVE AT THE OPENING OF THE KERB INLET LEAVING A 100mm GAP TO ACT AS AN EMERGENCY OVERFLOW.
  - SLEEVE MUST BE PLACED AGAINST THE KERB TO PREVENT BYPASS.
  - FIT SLEEVE TO ALL INLETS DOWNSTREAM OF THE WORKS.
  - FOR DRAINAGE WORKS FIT GEOTEXTILE FABRIC OR GEO BAGS TO UPSLOPE FACE OF ALL OPEN PIPES.
  - MAINTAIN AN OPENING AT THE TOP OF THE PIPE OF 1/3 OF THE PIPE DIAMETER.
  - THE FILTERS ARE TO BE CLEANED AND MAINTAINED DAILY.
  - ALL CARE SHOULD BE TAKEN TO MINIMIZE SEDIMENT REACHING THE STORMWATER SYSTEM BY MINIMIZING EXCAVATION WORKS AND PREVENTING EXCESS WATER FLOW THROUGH WORKS.

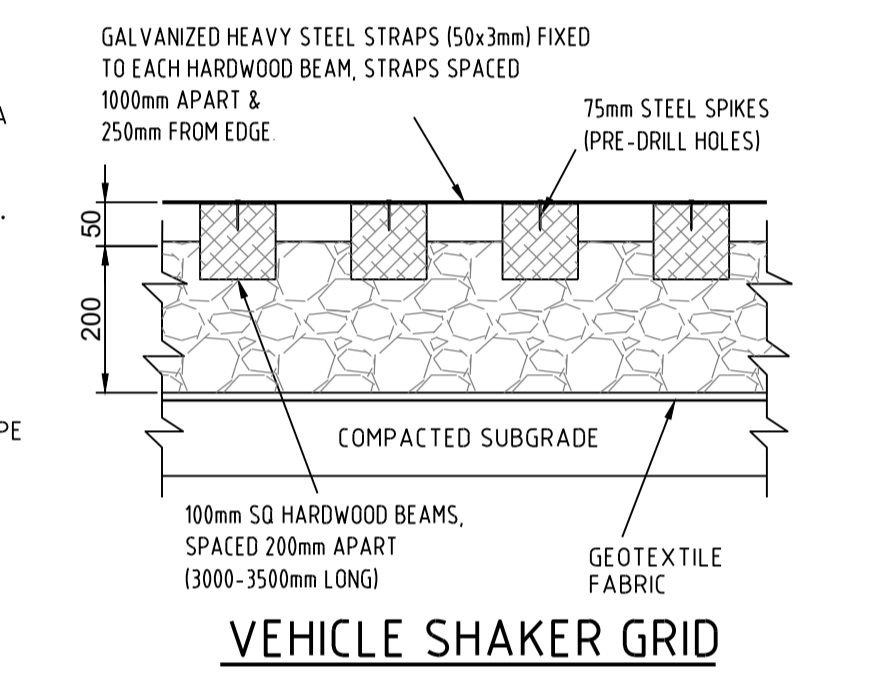
- SITE ENTRY/EXIT CONSTRUCTION NOTES:-**
- STRIP TOP SOIL & LEVEL SITE. PROVIDE CATCH DRAIN AT SIDES TO DIRECT RUNOFF WATER TO SEDIMENT TRAPS.
  - COMPACT SUBGRADE AND REMOVE ANY HIGH POINTS.

- COVER AREA WITH GEOTEXTILE FABRIC. THIS MAY BE WOVEN OR NEEDLE PUNCHED PRODUCT WITH A MINIMUM CBR BURST STRENGTH (AS3706.4-90) OF 2500 N.
  - CONSTRUCT 200mm THICK RUBBLE PAD OVER GEOTEXTILE USING ROAD BASE OR 30-40mm AGGREGATE. MINIMUM LENGTH 15 METRES OR TO BUILDING ALIGNMENT. MINIMUM WIDTH 3 METRES. CONSTRUCT 300mm HIGH HUMP IMMEDIATELY WITHIN BOUNDARY TO DIVERT WATER TO A SEDIMENT TRAP.

- PROVIDE RAMPS AT ENDS AND SIDE OF GRIDS. IF DEPRESSIONS OCCUR IN THE RAMPS DURING USE. ADD ADDITIONAL MATERIAL.

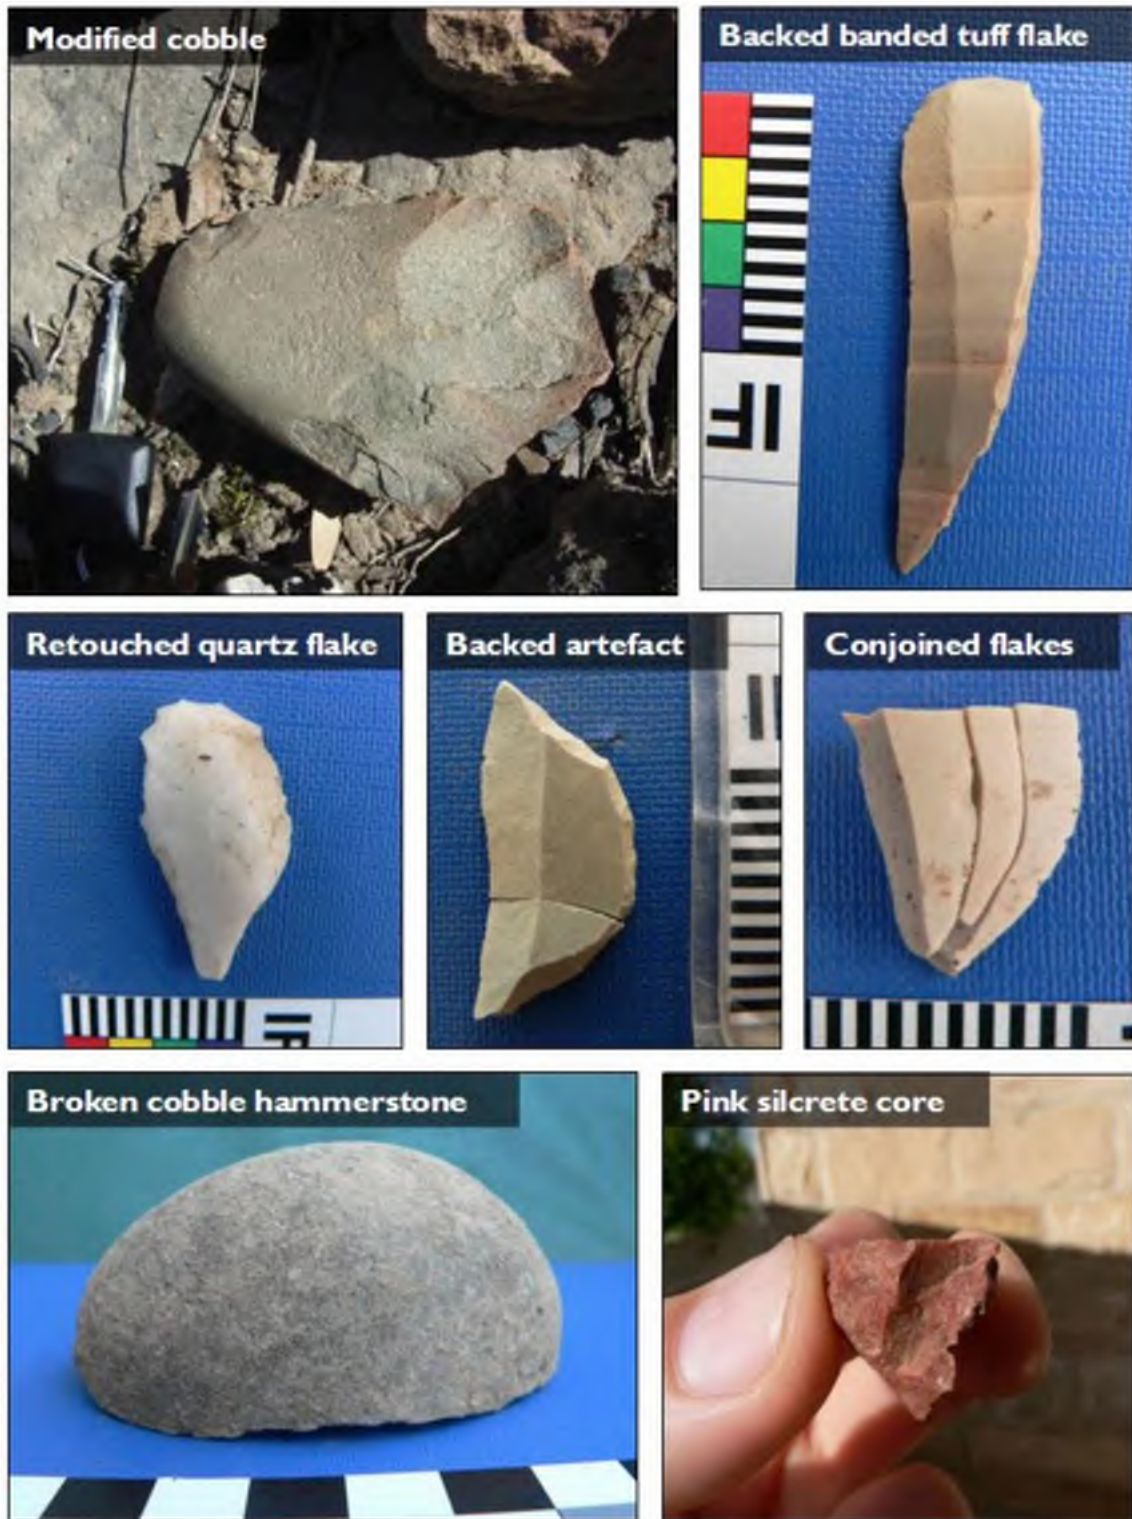
Figure A.1 Examples of the types of Aboriginal stone artefacts which could be found in the local area (Transport for NSW 2022:26).

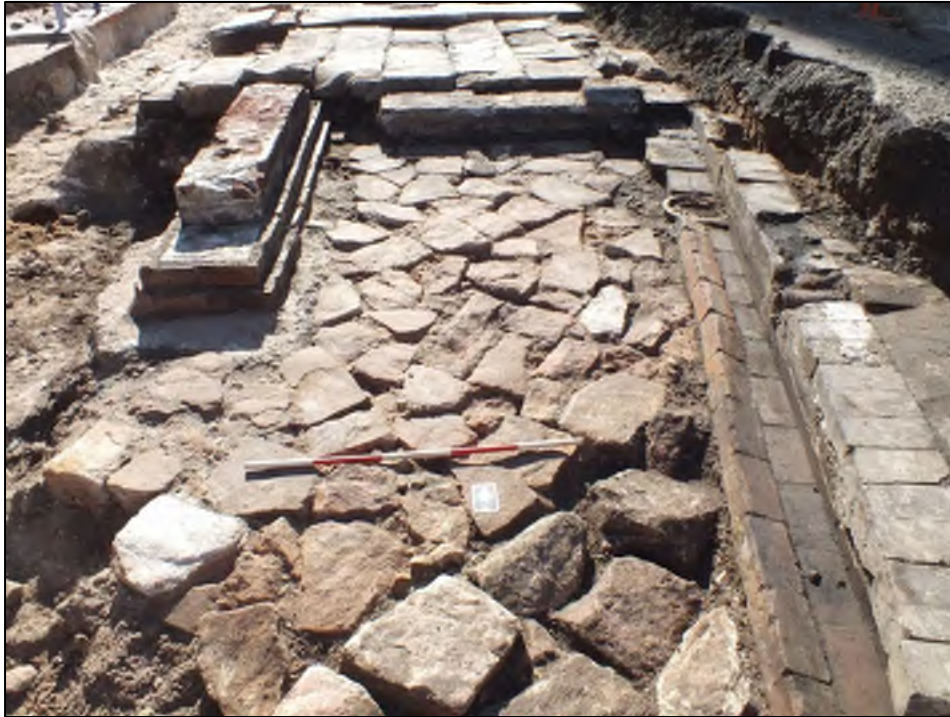
**Figure A.2 Sandstone pavers uncovered during the SBA archaeological excavations, 2024.**

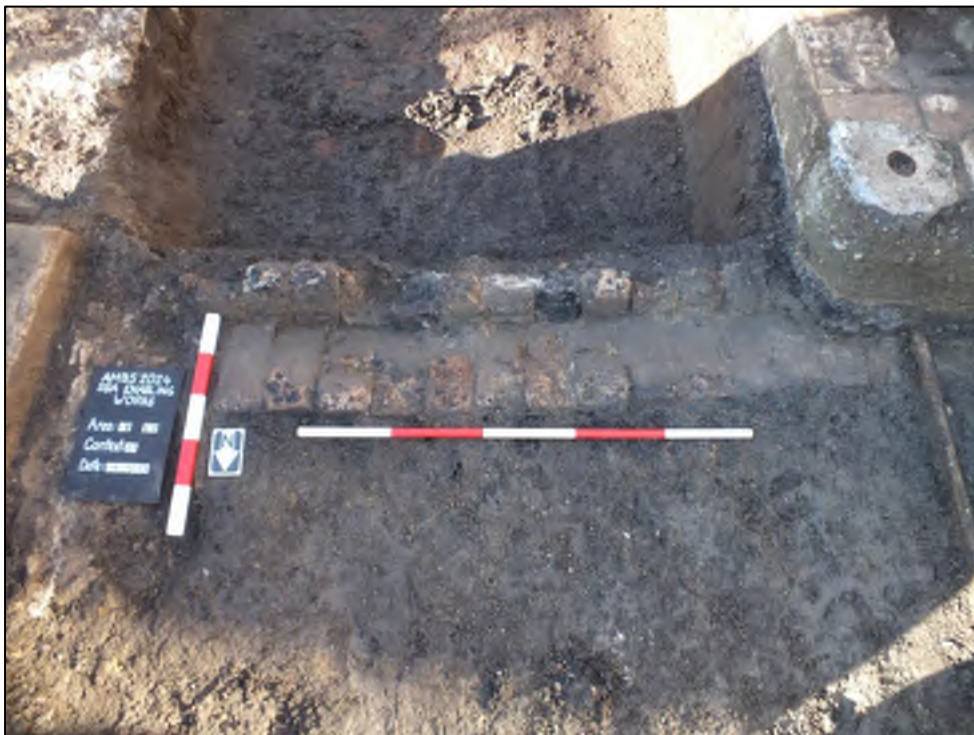
**Figure A.3 Example of drainage feature identified during the SBA archaeological excavations, 2024.**

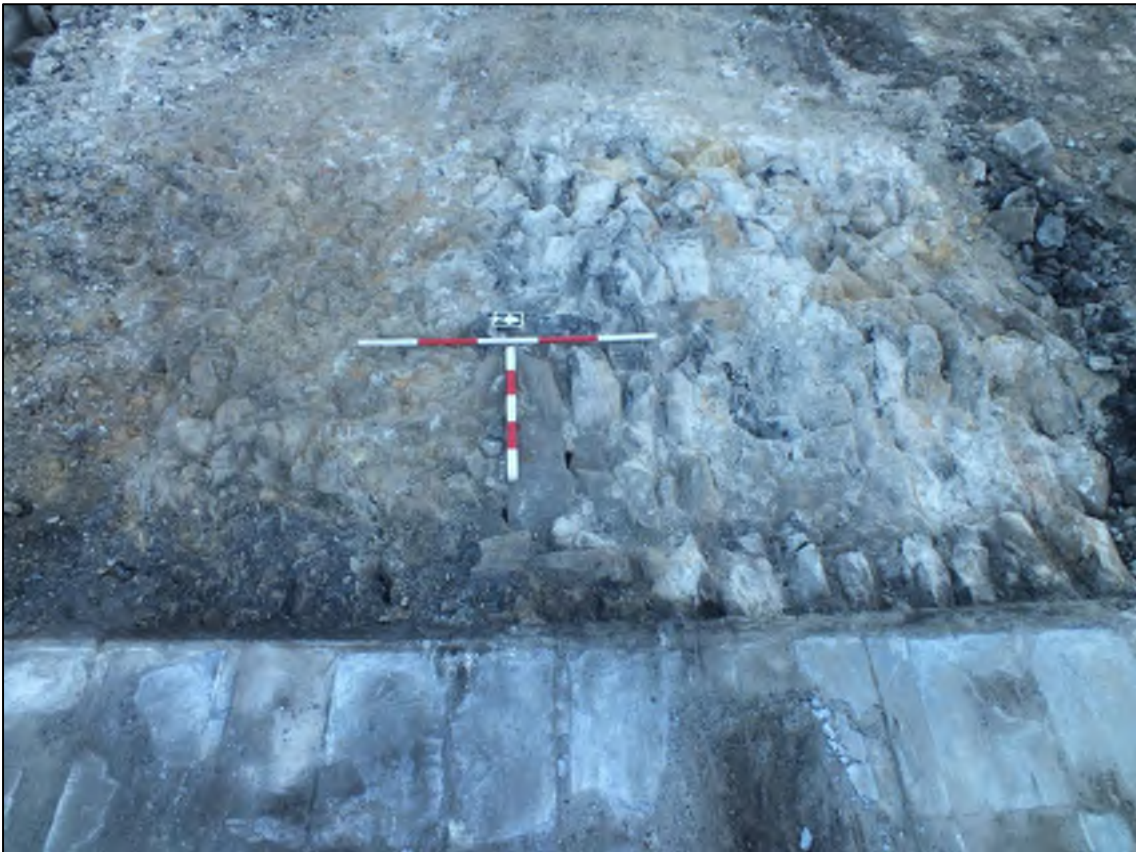
Figure A.4 Example of Telford style road base identified during the SBA archaeological excavations, 2024.
