Project number: S240427
Reference: S240427MR11

**Sydney Biomedical Accelerator
Noise and Vibration Monitoring Report – April 2026**

Resonate Consultants Pty Ltd (Resonate) was engaged to undertake unattended noise and vibration monitoring at the construction site of the Sydney Biomedical Accelerator, located within the University of Sydney Camperdown campus to monitor the effect of construction noise and vibration at nearby sensitive receivers.

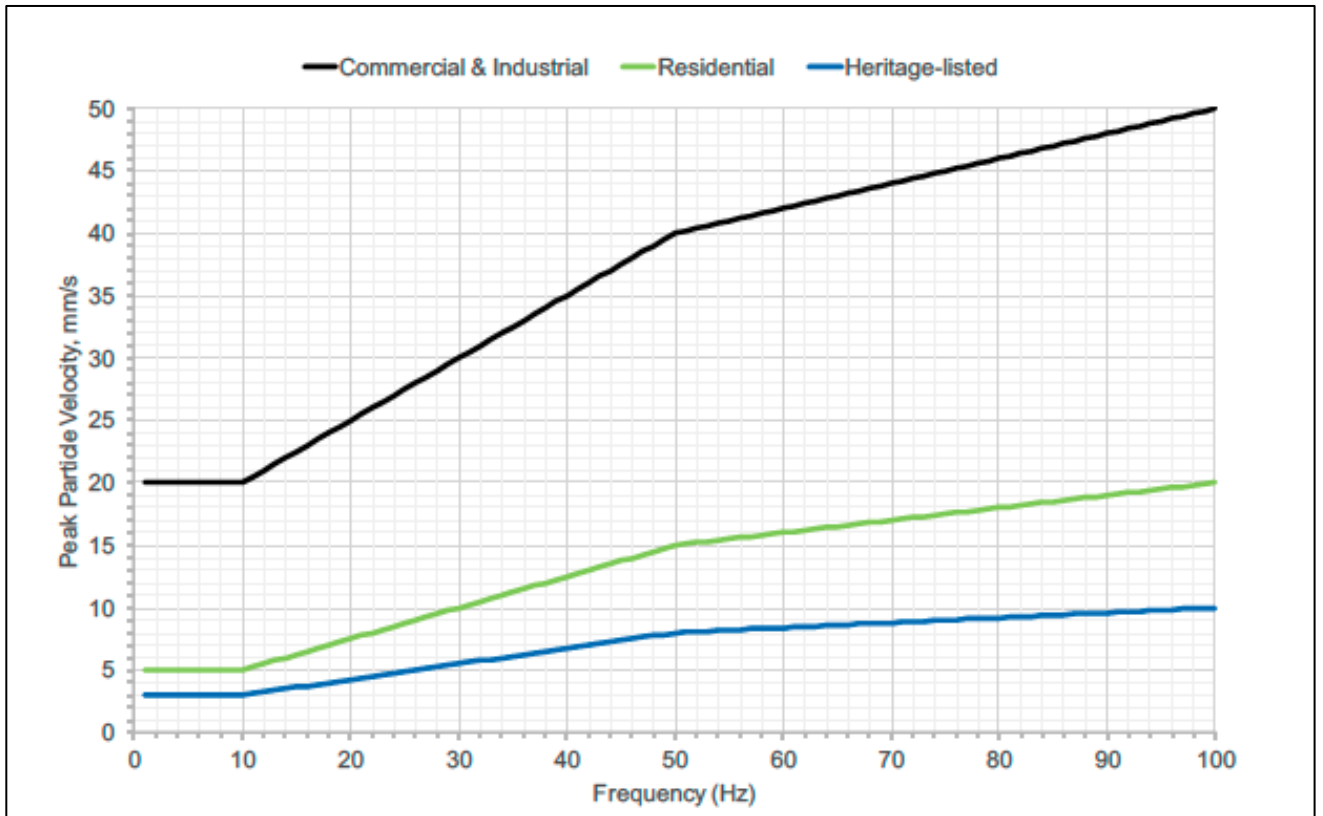
Figure 1: DIN 4150-3 Guideline Values

DIN 4150-3 states that exposing buildings to vibration levels higher than that recommended in the table below does not necessarily result in damage. Rather it suggests that these limits are the levels of vibration at which experience has shown that damage leading to a reduction in the serviceability will not occur. The most stringent DIN 4150-3 vibration limits for different types of building structure are presented in Table 2 with the frequency dependant criteria presented in Figure 1.

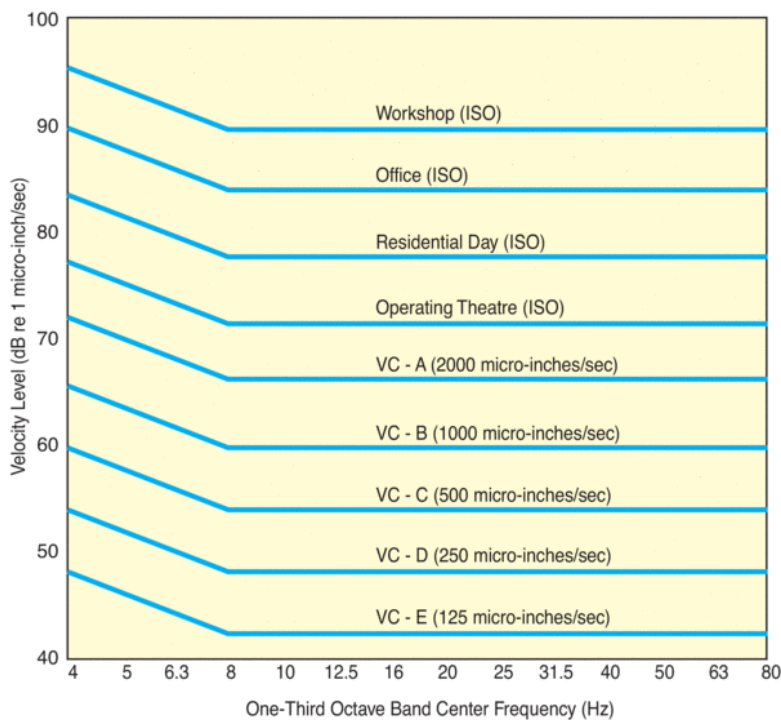
Figure 2 VC curves

It should also be noted that the SWHB houses specialised medical equipment that may require more stringent criteria. In the absence of manufacturer specifications, the Vibration Criterion (VC) curves (as per ANSI S2.71/ISO 2631) will be used to define default vibration criteria, these are shown in Figure 2. These curves provide conservative RMS vibration limits, ranging from VC-A (0.050 mm/s) suitable for general labs to VC-E (0.003 mm/s) for ultra-sensitive instruments such as atomic force microscopes (AFMs).

The vibration monitor located within the CT room of SWHB adheres to the much stricter criteria of VC-A, which is equivalent to approximately 0.05 mm/s.

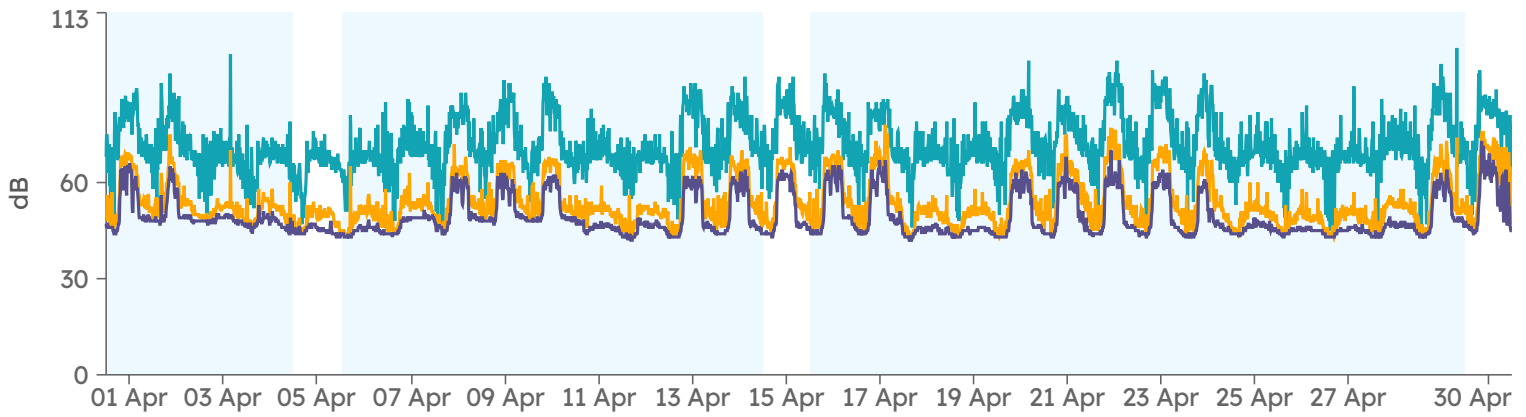
Sound Levels | NM02

LAeq **65** Day dB

LAeq **56** Evening dB

LAeq **51** Night dB

15 min periods 01 Apr 2026 - 30 Apr 2026

| Monitor | Date and time | Sound level, dB(A) | Equipment / noise source |
|---|---|---|--|
| NM02 | 9:11 am, 9 April 2026 | 86 | Heavy machinery operating |
| NM02 | 8:07 am, 14 April 2026 | 90 | Metal squealing |
| NM02 | 1:52 pm, 15 April 2026 | 91 | Continuous pump noise |
| NM02 | 7:43 am, 16 April 2026 | 94 | Heavy machinery operating |
| NM02 | 9:21 am, 22 April 2026 | 94 | Jack hammering |

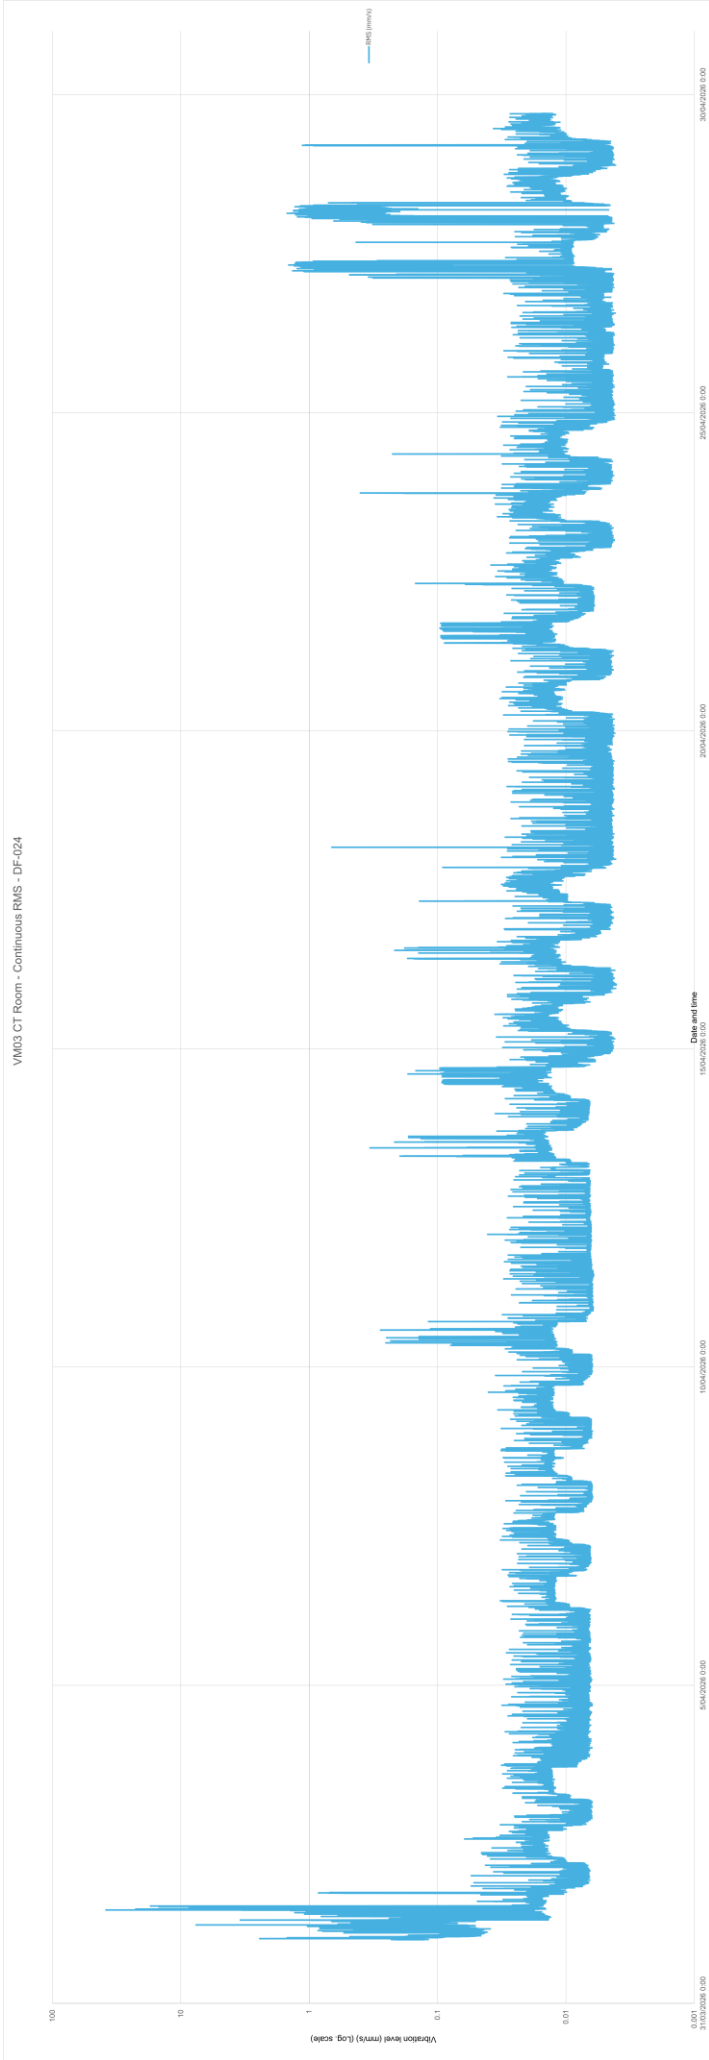
VM03 CT Room - Continuous RMS - DF-024

Frequent exceedances of the VC-A vibration criteria in Room 313 were recorded throughout the month. Considering the highly stringent criteria of the room it is unlikely that all exceedances were induced by construction activities. Resonate has recommended to RCC that stakeholder engagement should be undertaken to determine whether the vibration levels experienced in the room have impacted operation and/or imaging of the CT scanner. If no issues are raised or identified, we recommended increasing the criteria to reduce the number of false alerts.
