Project number: S240427
Reference: S240427MR8

Sydney Biomedical Accelerator Noise and Vibration Monitoring Report – January 2026

January 2025 Full report

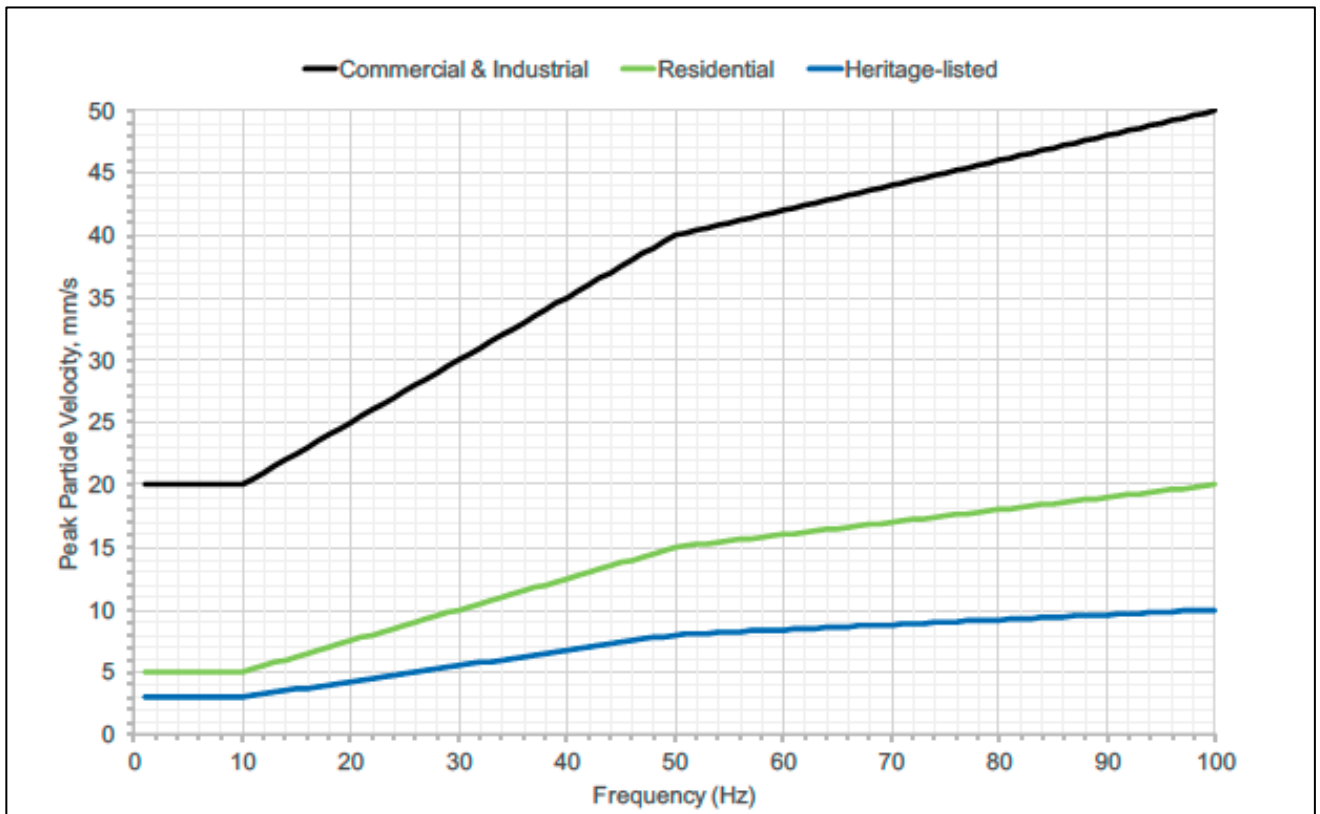
Figure 1: DIN 4150-3 Guideline Values

DIN 4150-3 states that exposing buildings to vibration levels higher than that recommended in the table below does not necessarily result in damage. Rather it suggests that these limits are the levels of vibration at which experience has shown that damage leading to a reduction in the serviceability will not occur. The most stringent DIN 4150-3 vibration limits for different types of building structure are presented in Table 2 with the frequency dependant criteria presented in Figure 1.

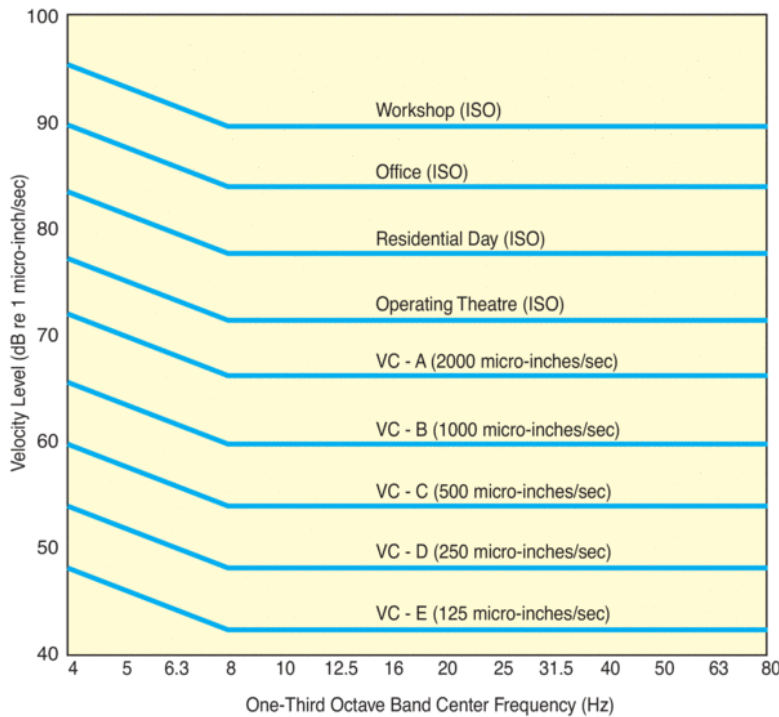
Figure 2 VC curves

It should also be noted that the SWHB houses specialised medical equipment that may require more stringent criteria. In the absence of manufacturer specifications, the Vibration Criterion (VC) curves (as per ANSI S2.71/ISO 2631) will be used to define default vibration criteria, these are shown in Figure 2. These curves provide conservative RMS vibration limits, ranging from VC-A (0.050 mm/s) suitable for general labs to VC-E (0.003 mm/s) for ultra-sensitive instruments such as atomic force microscopes (AFMs).

The vibration monitor located within the CT room of SWHB adheres to the much stricter criteria of VC-A, which is equivalent to approximately 0.05 mm/s.

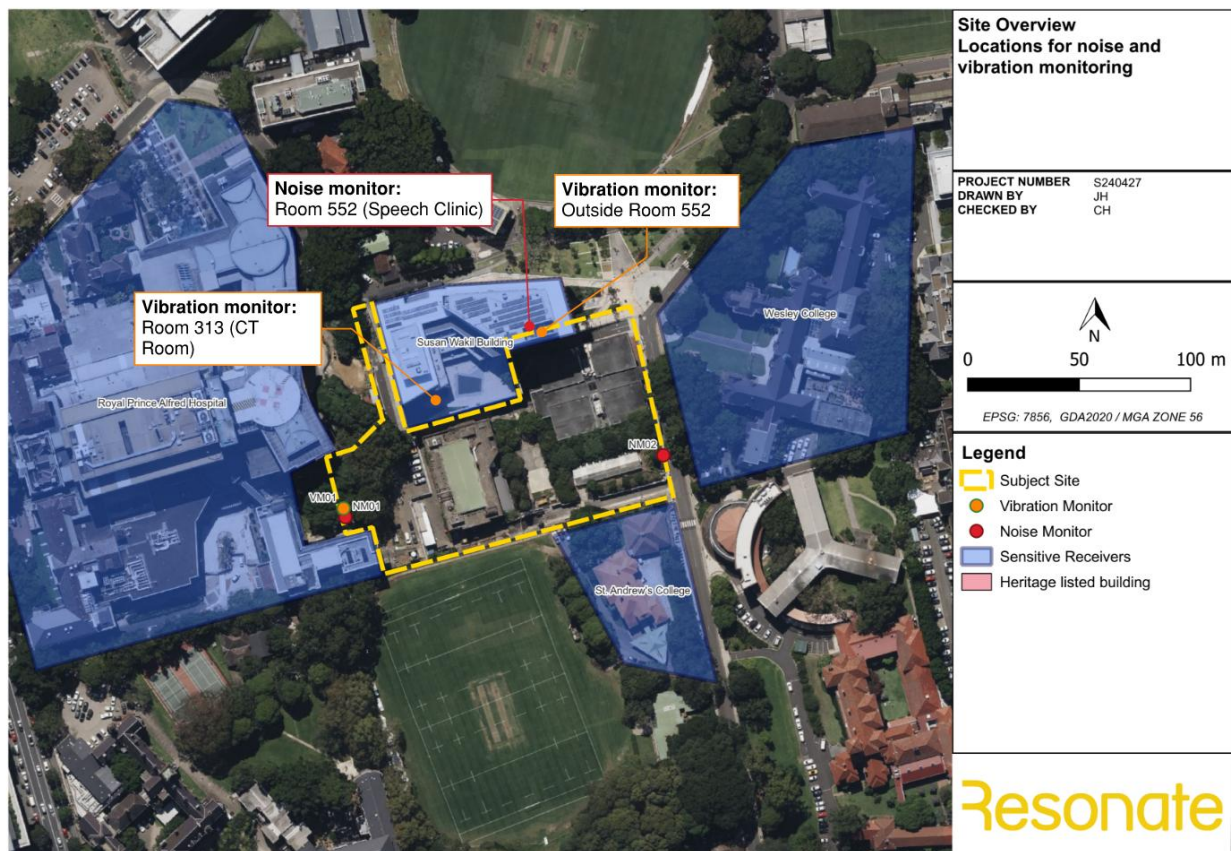
Figure 3 Unattended noise and vibration monitor locations

ID	Monitor	Location
NM01	SiteHive Hexanode noise monitor	South-East boundary of Royal Prince Alfred Hospital
NM02	SiteHive Hexanode noise monitor	East boundary of construction side, North of St. Andrew's College
NM03	SiteHive Hexanode noise monitor	Inside the Susan Wakil Health Building Speech Clinic (Room 552)
VM01	Avatrace vibration monitor	South-East boundary of Royal Prince Alfred Hospital
VM02	Avatrace vibration monitor	Inside the Susan Wakil Health Building Speech Clinic (Outside Room 552)
VM03	DataFlex vibration monitor	Inside the Susan Wakil Health Building adjacent to CT Room (Room 313)

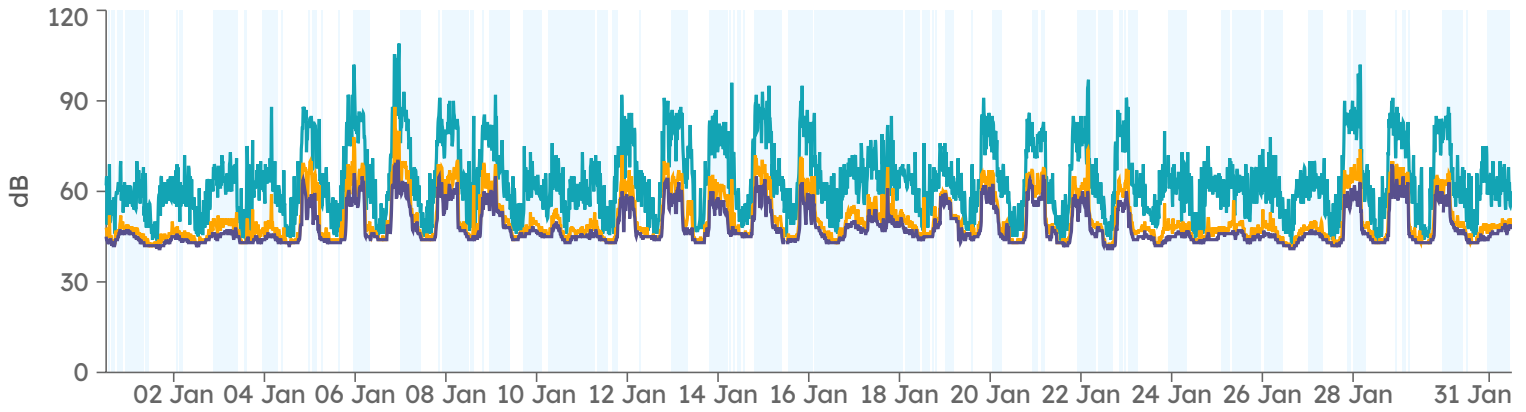
Sound Levels | NM01

15 min periods 01 Jan 2026 - 31 Jan 2026

Monitor	Date and time	Sound level, dB(A)	Equipment / noise source
NM01	10:57 am, 14 January 2026	85	Vehicle horn and workers yelling
NM01	8:42 am, 20 January 2026	85	Metal crashing and excavator operating
NM01	12:57 pm, 23 January 2026	84	Vehicle horn
NM02	3:56 pm, 14 January 2026	96	Large item being dropped

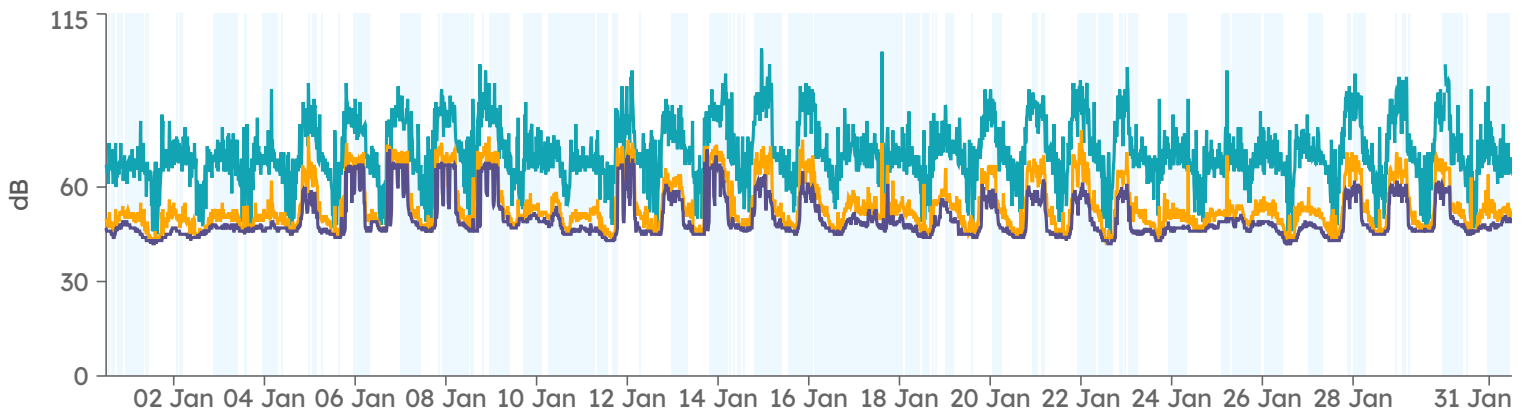
Sound Levels | NM02

15 min periods 01 Jan 2026 - 31 Jan 2026

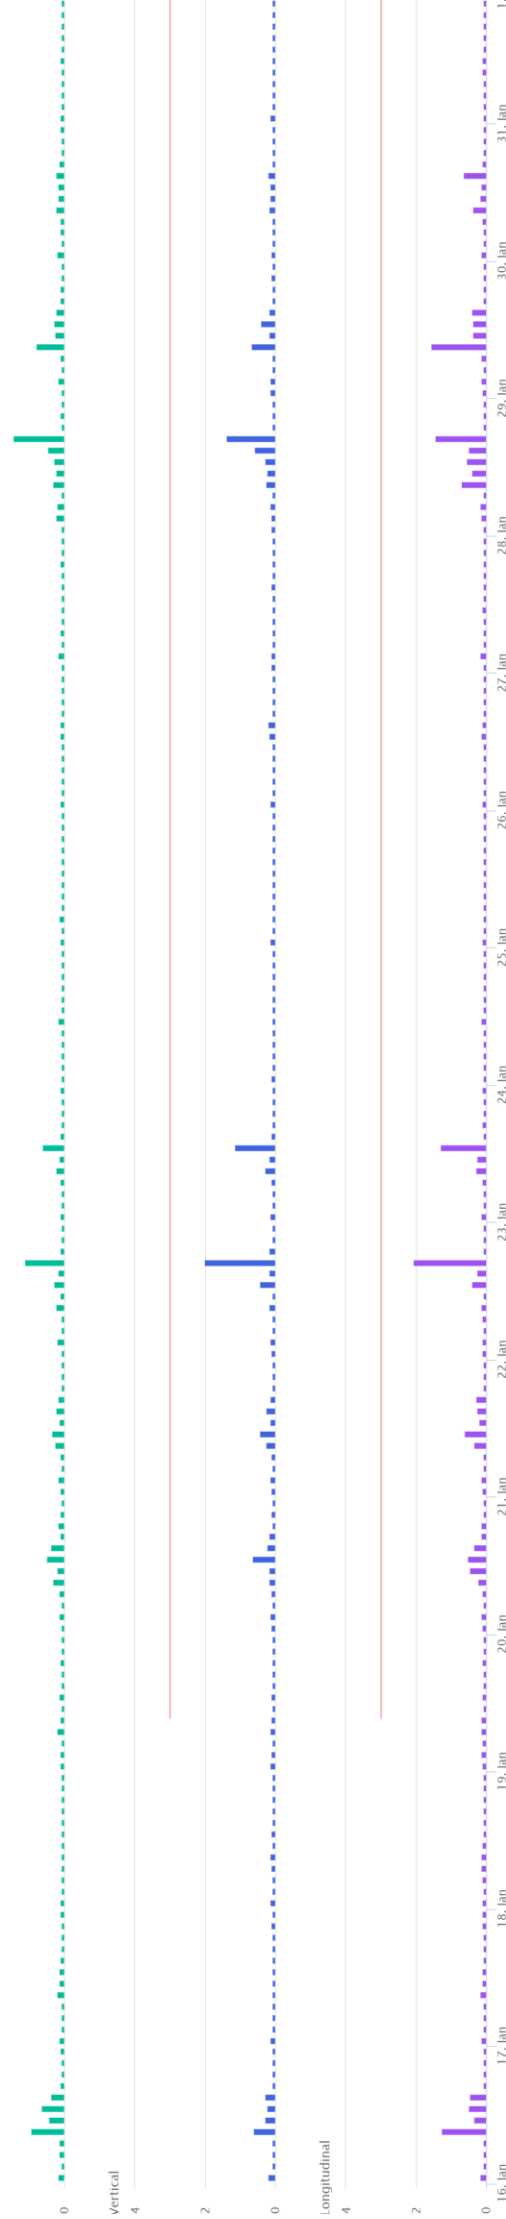
RPAH external (VM01)

There were no exceedances of the vibration criteria at VM01 or VM02. A large spike in PPV can be seen at VM02 on 15 January, this is not due to construction activity but rather the replacement of the monitor.

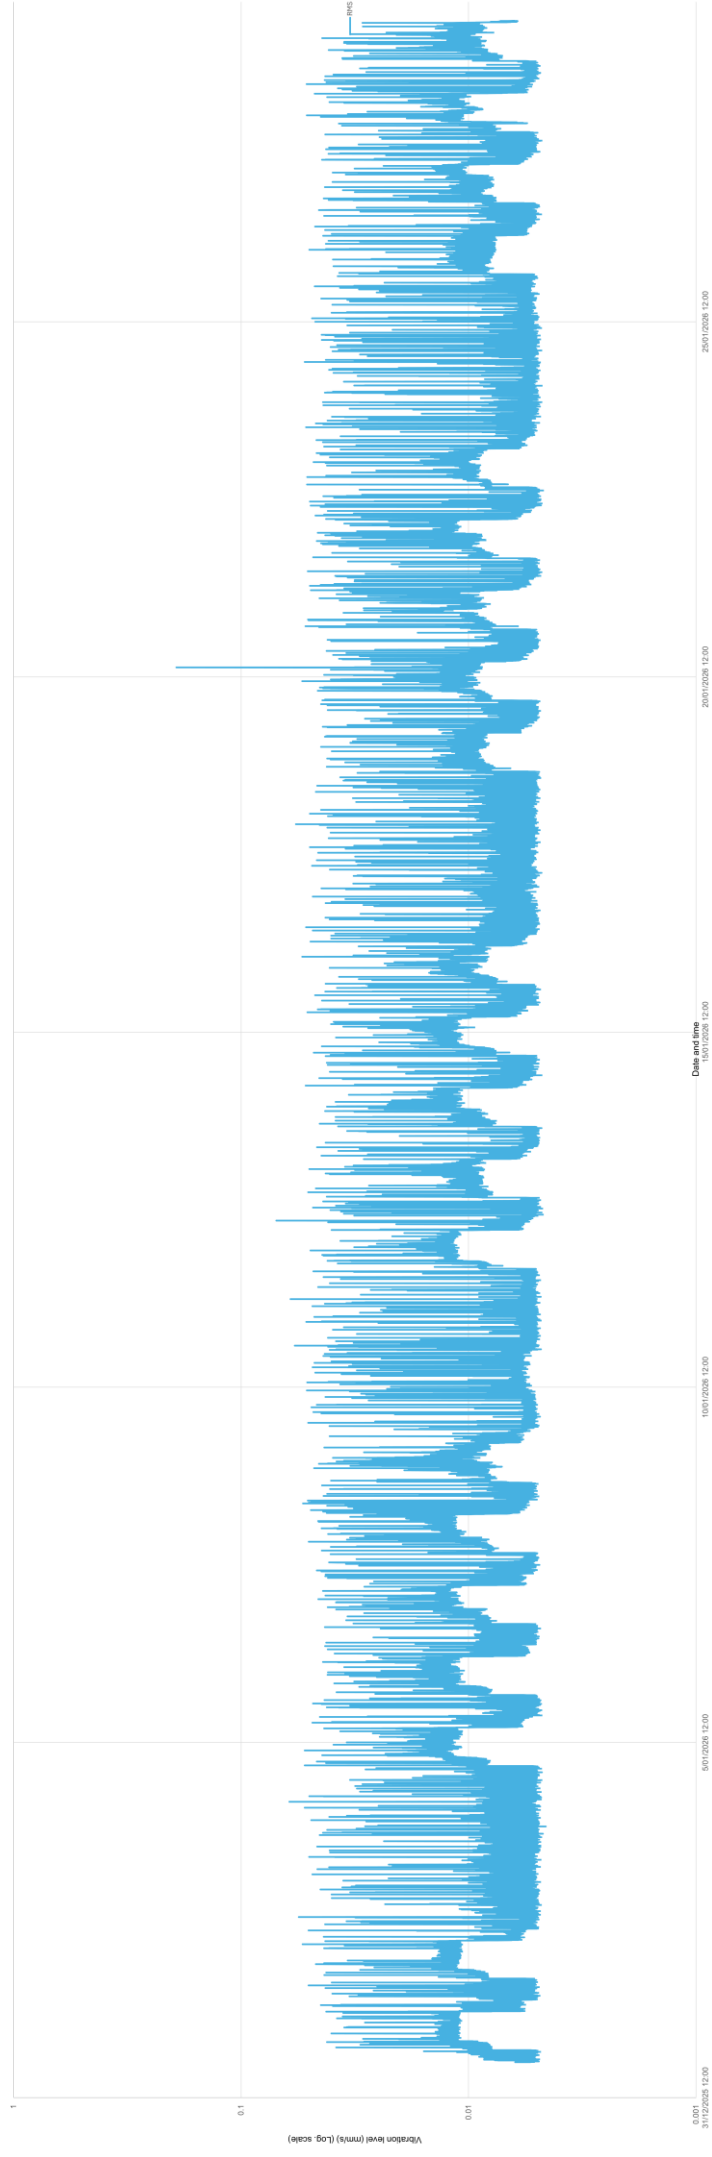
VM03 CT Room - Continuous RMS - DF-024

Frequent exceedances of the VC-A vibration criteria in Room 313 were recorded throughout the month. Considering the highly stringent criteria of the room it is unlikely that all exceedances were induced by construction activities. Resonate has recommended to RCC that stakeholder engagement should be undertaken to determine whether the vibration levels experienced in the room have impacted operation and/or imaging of the CT scanner. If no issues are raised or identified, we recommended increasing the criteria to reduce the number of false alerts.
